Case Study

1600 Busse Rd-Concrete Repair

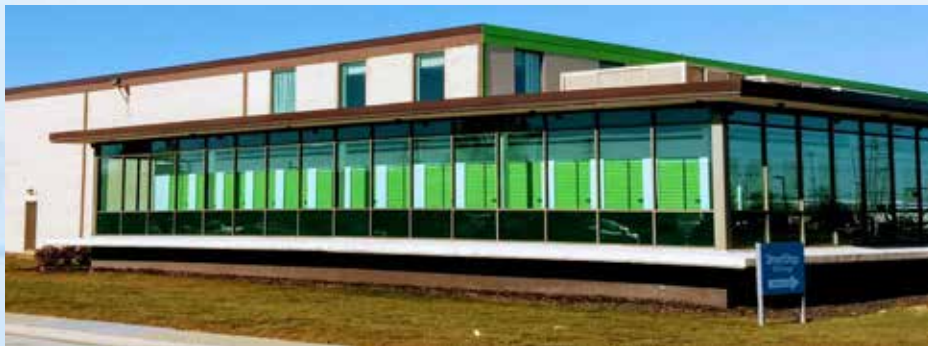
- Chipping and cracking concrete detail on front elevation
- Exposed metal rebar
- Spalling corroded concrete was an eyesore

Weathershield was commissioned to make repairs to the concrete detail on the front elevation of the building. Our experienced operations and field technicians developed a plan to repair and renew the aging concrete structure. The concrete was spalling, badly cracked and had exposed metal rebar that was beginning to corrode.

After prepping and treating the rebar our team utilized a combination of routing & filling cracks as well as various methods of concrete restoration to bring the structure back to its former glory. Finally, it was coated with two coats of waterproof paint.
